FROM LITTLE THINGS—BIG THINGS GROW

OTHERWISE KONW AS “UPGRADING TO LED GLOBES IN MY 1982 4/4”

Geoff Hollings

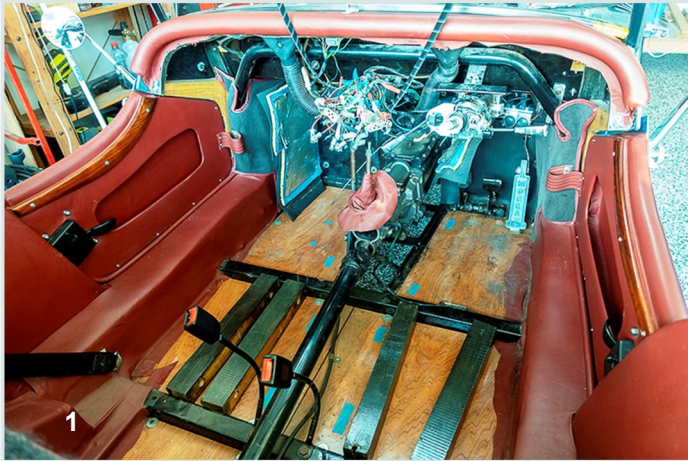
What started out as a job to replace the incandescent globes with LED globes led to the removal of the dashboard and instruments, seats, transmission tunnel, indicator switch and heater fan

The task involved removing the lenses, globes, one brake light assembly, the dash, all the instruments, THEN the seats, drive shaft tunnel, gearbox tunnel, heater fan and indicator switch. [photo 1]

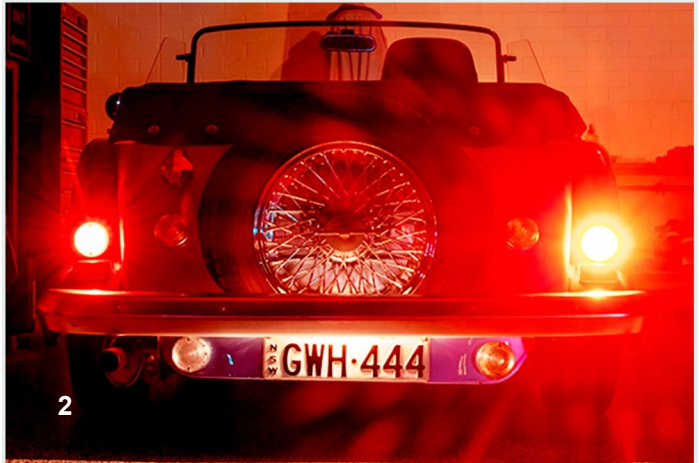
I did notice that the starlock washer which secured the capture nut was heavily corroded and loose, with the result that it was difficult to get the screw into the fitting. A quick search on eBay located some starlocks which arrived a few days later and duly fitted. The new red LED globes are about double the brightness of the old filament globes, so it is a job worthwhile. [photo 2] Second task was the reverse globes. An easy job this time. I did notice one of the old globes was only 5w instead of the normal 21w, so the lights are much better now. [photo 4]

Worth the effort; the LED globes are about twice as bright as the old incandescent globes

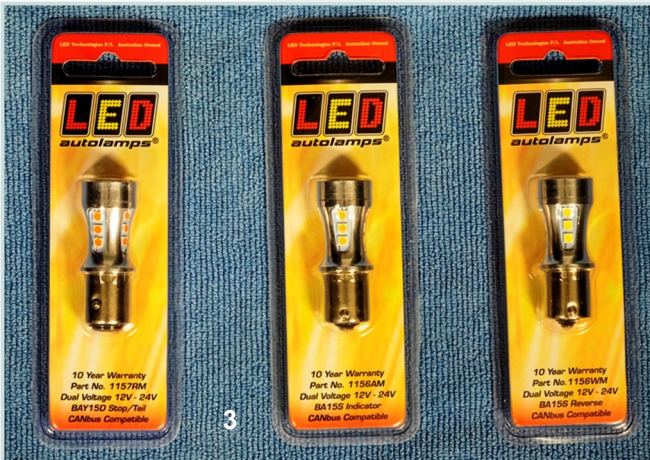
Replacement LED globes for brake/tail, indicator and reversing lights

As the local car spare parts shops did not keep them in stock, I ordered brake/tail, indicator, reverse and headlight globes from them directly. The globes duly arrived by post. [photo 3]

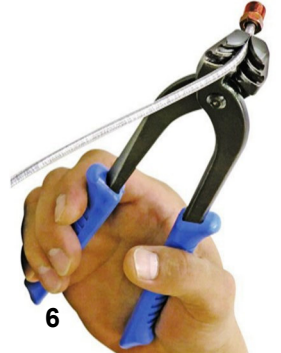
The handy brake line bending tool

broken on one side and this explained it. So, I ordered a replacement switch from the UK.

The arm on the old unit had been bent to come out in front of the dash when it was installed in the factory, but the replacement arm was straight and would not clear the dash when installed.

I spoke with a couple of club members and one offered to help using brake line bending tools. After doing a test bend on the old arm, we were able to bend it using a special pair of pliers designed for bending brake lines. Thanks to Geoff Williams for his help. I'll buy a pair when I need to replace it in another 30 years. [photo 6]

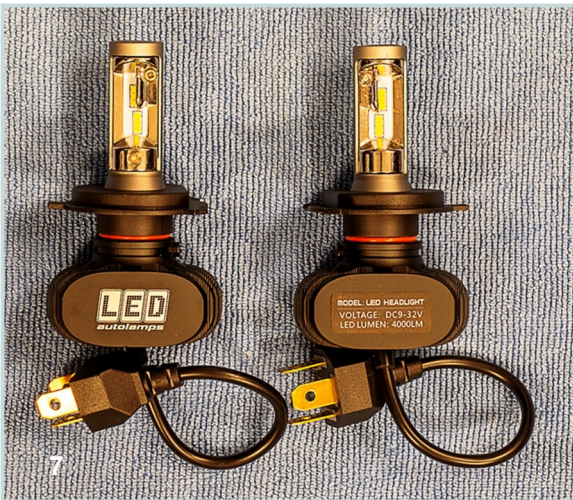
The LED headlight globes

The screws that secure the headlight are also the beam adjusters

headlight globes. Removing the headlight surround revealed that the screws to remove the lens to get access to the globe were the same screws used for the beam adjustments. After carefully noting the position of the beams on the back of the garage, I proceeded to remove the lens and replace the globes. [photo 7 & 8]
