Replacing the Differential Pinion Seal in a Morgan Plus 8

Differential Pinion Seal replacement

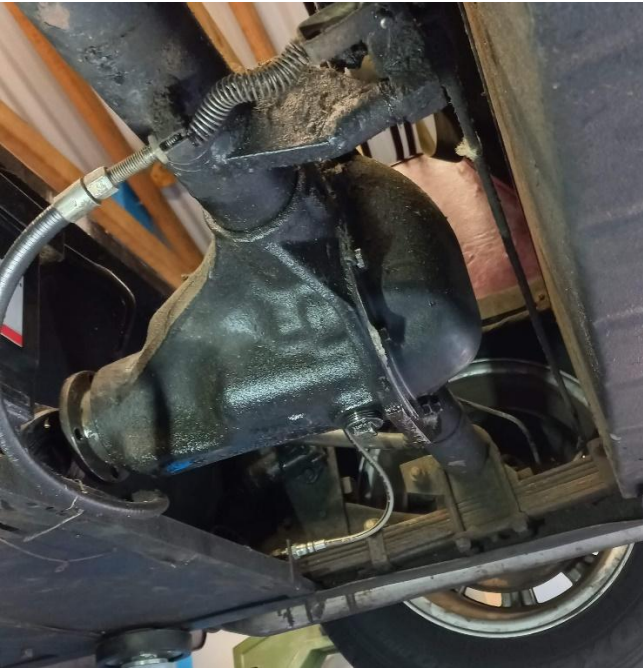
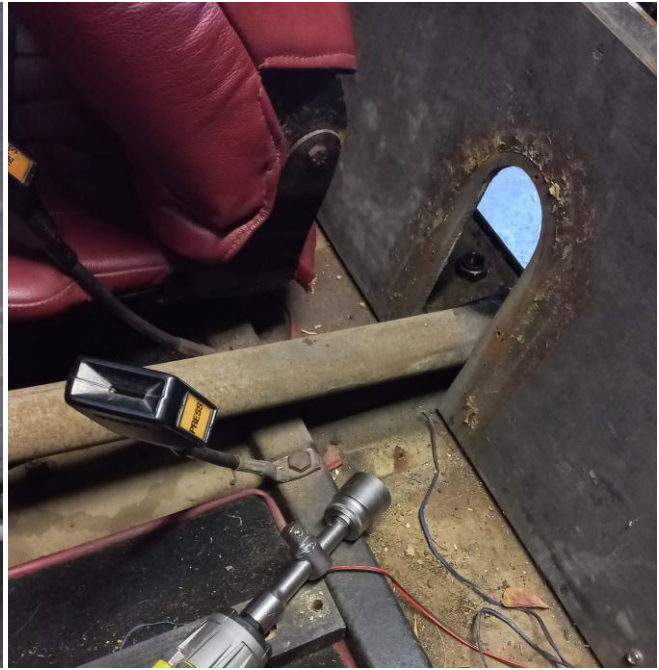
I managed to limit the “remove and refit” of body elements to the passenger’s seat, minor carpets and underlay, the tailshaft tunnel, and the luggage deck. As shown in the below photos, the rear section of floor continues under the differential pinion towards the rear and obstructs access to the differential pinion from underneath. Additionally, the angled timber panel (behind the seats) denies easy access to undo the highly tensioned pinion nut from within the car.

The answer was to work from inside the car on either side of the angled timber panel, through the hole made for the tailshaft. Once the four tailshaft-to-pinion fixings were removed, I could tackle the big pinion nut. The “heavy lifting” was done with a $\frac{3}{4}$ ” drive compressed air impact driver and a socket extension, through the hole in the angled timber panel. The usual amount of cajoling and prising saw the old, original, leather oil seal on the bench. I was pleased to see that there was no wear or even a “witness mark”, where the old seal might have abraded the pinion.

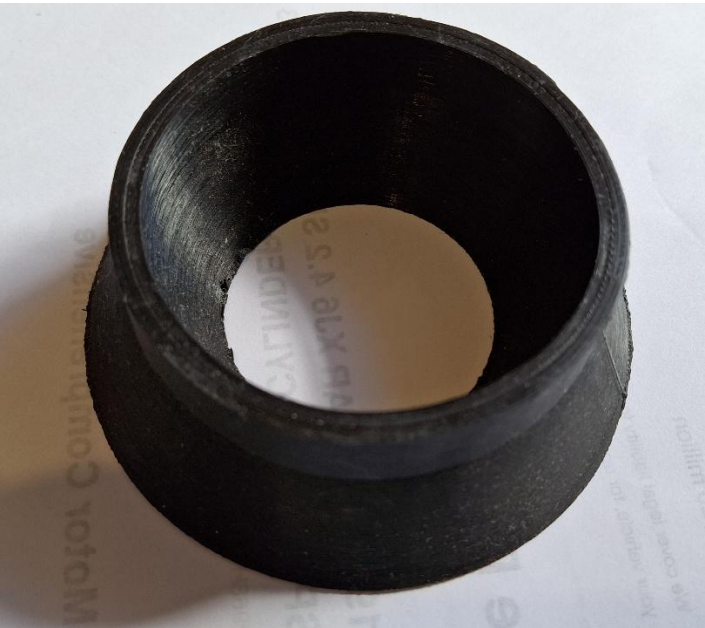
3D printed drift

I had little confidence that I could evenly press and refit the seal given the encumbrances of the Morgan body, as far as I had it stripped. In the finish I 3D printed a substantial drift to help drive the seal into its journal, fixing the drift at the differential using zip ties. Two free hands then permitted the usual careful persuading with a length of 30mm square sectioned pine and a dead blow hammer.
