FROM LITTLE THINGS—BIG THINGS GROW

OTHERWISE KONW AS “UPGRADING TO LED GLOBES IN MY 1982 4/4”

Geoff Hollings

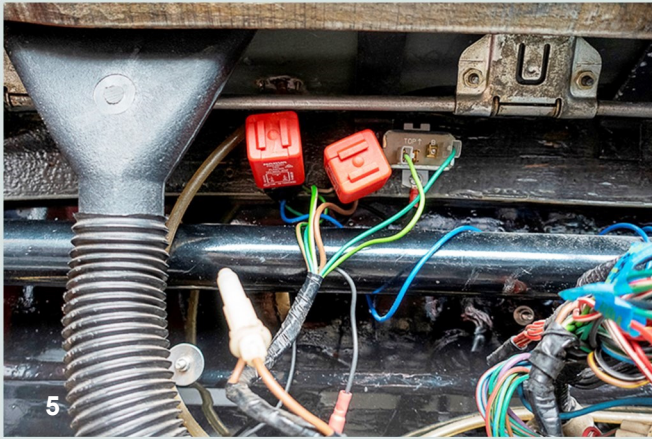
The dashboard out to provide access to remove the indicator, and hazard plugs, change the polarity and relocate them

I removed the dash, removed the indicator, and hazard plugs, changed the polarity as needed and relocated them. [photo 5] The indicators and hazards now work fine, and like the other lights are about double the brightness. The \$5 mini buzzer from Jaycar was so loud and piercing that I had to install it in a small box to reduce the sound level.
