## Are Your Rear Brakes Working?

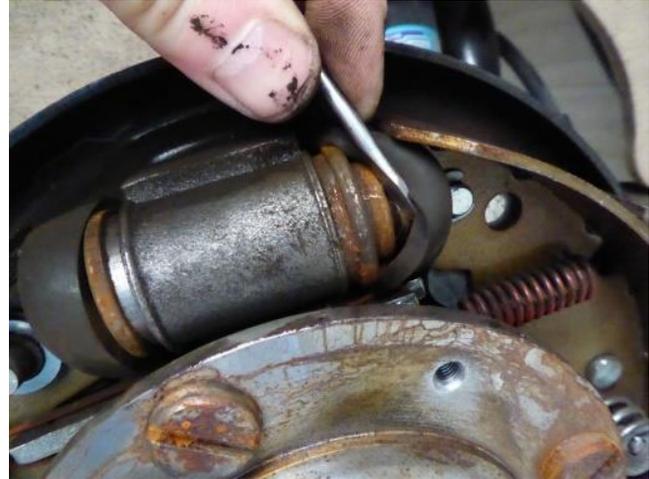
Poking around the various components of the brakes revealed the pistons in the brake cylinder were not moving at all – even when the brake pedal was applied they would not expand or retract. This was true on both rear brakes. Peeling back the rubber dust protectors revealed the problem – rust and lots of it on the pistons. They were frozen solid.

*Pulling back rubber boot revealed rust*

The solution in this case was to replace the cylinders (Part #CW 15953). They are available from dealers or on eBay. Before fitting the new cylinders I removed the rubber boots and liberally applied Bosch rubber grease which is meant for exactly this purpose. More was applied on the inside lip of each boot to help stop ingress of air to the cylinder. The GoMog website has a detailed article on removing/installing these cylinders.

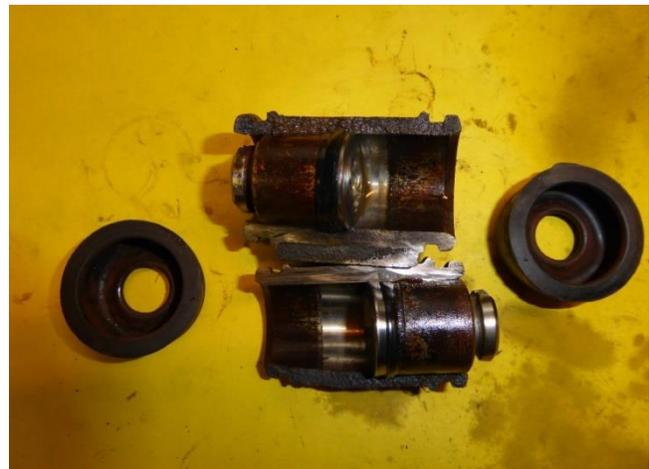
The photo to the right shows one of the cylinders in cross section. Note the rust on both the pistons and the cylinders.

- Brake cylinders from 1993 are cast iron, not aluminium as in older models. Iron rusts.
- When installed, they were not lubricated. Bare iron rusts.
- This car had spent some of its short life near the sea. Salt promotes rust.
- Lack of use meant the brake pistons/cylinders were more likely to rust.

*Cross sectioned brake cylinder showing corrosion*

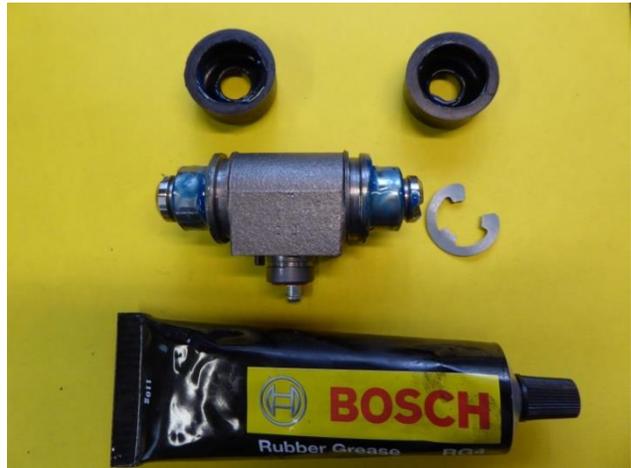
New brake cylinder with Bosch rubber grease applied
