A less expensive method of repairing a chrome-plated grill

Bill Turner – Morgan Club Member 984

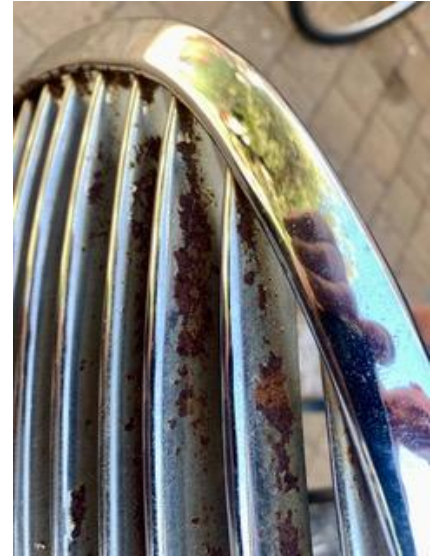
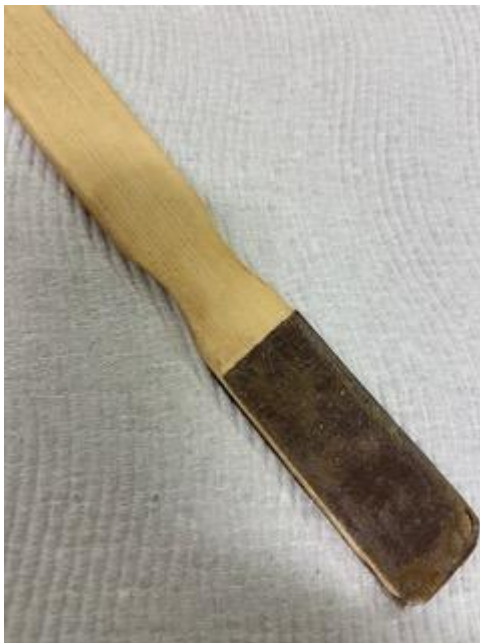
This is a photo of the rust problem on the grill from our XK150 Jaguar. In the beginning, I attempted to find a chrome-plating enterprise that could clean up the rust and re-chrome the grill, but nobody wanted to tackle the problem; too complicated and too intricate they all said. Seems they all prefer relatively flat bumper bars.

The **first stage** involved the clean-up of the rusted areas with the use of a thin piece of wood (something akin to a 30cm ruler) to which I super-glued a strip of Norton P240-J emery paper; special in that it had a cotton material (not paper) backing, that when torn, would tear straight. However, it did take a while to do this work, as it does need to be done carefully, in order to prevent unnecessary scratching of the good chrome areas.

The **second stage** involved the use of a degreaser to ensure the metal surfaces were clean. The **third stage** involved the application of a rust surface inhibitor, in order to prevent further rust.

The **fourth stage** involved the application of a special clear hard-surface paint, which after drying, was followed by the **fifth stage**, the application of Kromebrite liquid-chrome-enamel paint from a spray can, with final detail touch up with the help of an artist's brush.

The products for stages 2-4 come in a pack which is called POR15 Stop Rust Kit, manufactured in the USA but available in Australia. Although the resulting chrome colour is slightly foggy compared with an actual chrome-plated surface, when the chrome enamel paint is applied to areas that are not on the leading edges of the grill, it is hard to see any significant difference.

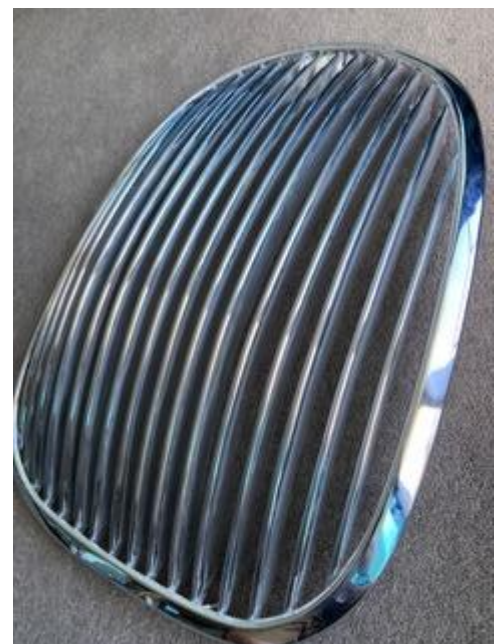
The key issue with this kind of repair work is to get in early, and not to wait until it becomes a major issue. The arresting of the rusting process and the sealing of the affected areas with the special hard-surface paint has clearly demonstrated to other users, that this process provides a long-term solution to the rust problem on chrome plated areas.
